Exploring Visual Clues for Easy Navigation at Bus Stand, Rohtak (Haryana)

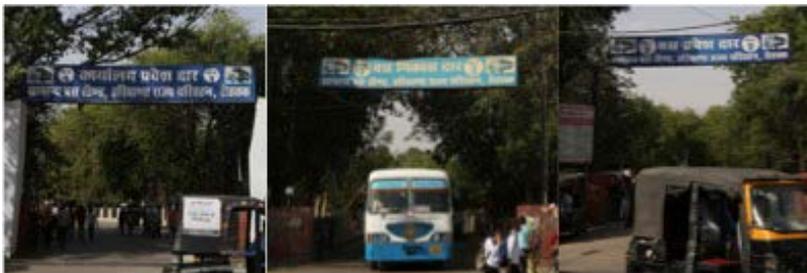
Fig. 1 Entrance Gate Bus Stand, Rohtak Image source: Author

The main entrances, exit, enquiry, ticket counters and other essential facilities within bus terminal should be distinct and clearly signed with the appropriate symbols. There are 3 Gates at bus stand. Gate no 1 is used for entrance to office building, parking area and auto stand. Gate 2 is used for entrance of buses and gate 3 for exit of buses. The entrance gates are well marked but exit points are not clearly, which often causes confusion for first time visitors. The identification sign of all the gates is not uniform format i.e. size; placement and colour of all three vary. Readability of entrance sign is hindered by tree or other station elements. The information is presented only in Hindi and is not supported by any symbolic representation. Information in bilingual format i.e. in both Hindi and English along with pictograms will enhance proper distribution of information among passengers belonging to various literacy and language backgrounds.

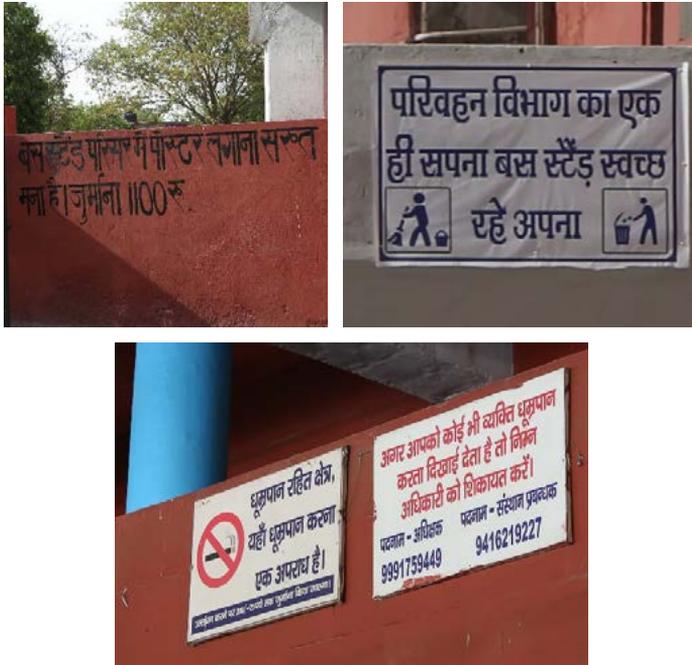
Fig. 2 Prohibitory Sign at bust stand Rohtak. Photo source: Author

Prohibition signage not in uniform format; few are hand painted on walls, few printed & glued on walls and some are printed on flex. These signs are not positioned in cone of vision most of them located above eye level. As per international transit signage standards all prohibitory signage should be presented in white background, black image and red slash and prefer to use circle.

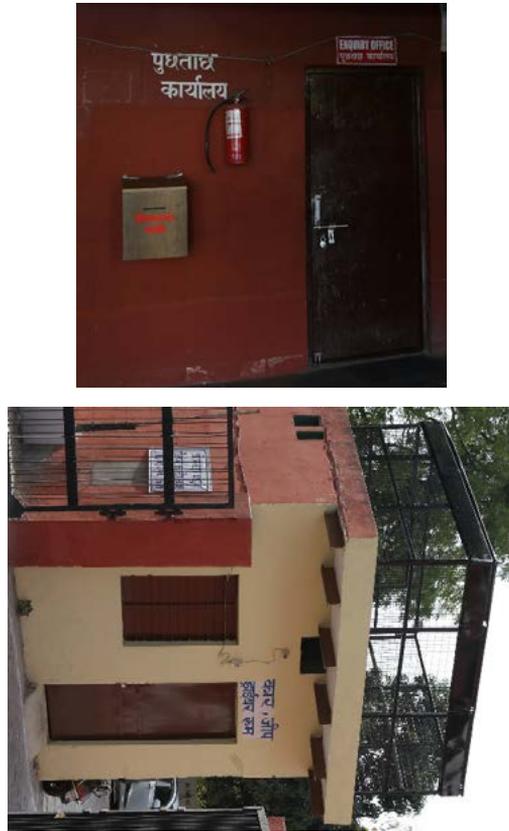
Fig. 3 Identification sign for various services offered at bus stand.

Enquiry counter not noticeably marked and there are no directional sign showing way towards enquiry window from platform.

The identification signage for amenities or facilities available within station area are not appropriate and up to the standards. There are no directional sign, which guide passengers towards various facilities or basic amenities like enquiry, drinking water, washrooms, food court or stalls, telephone; waiting area, ATM, postal service, etc. is not in uniform format. There are no map & directories showing plan of the building and all facilities/sections available in concourse areas or platform.

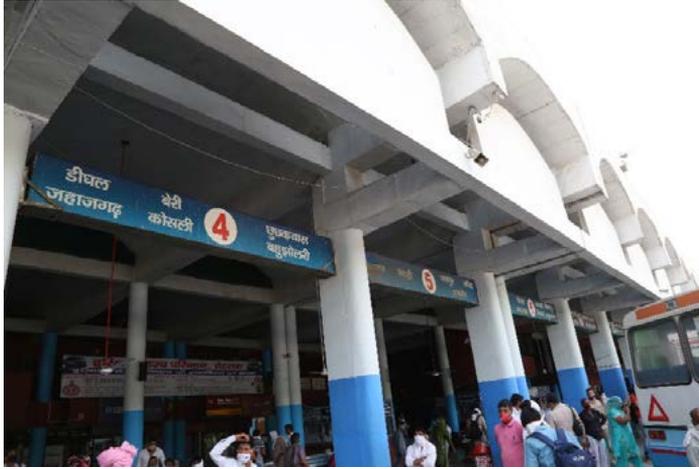
Fig. 4 Destination or route identification sign Photo source: Author

There is only one platform where track or bays for busses departure to various destinations take place. Track no and destinations served are mentioned on overhead identification sign but there are no advance and confirmatory directional signage displayed within terminal. The information is given only in Hindi and there is no colour coding to depict or differentiate various tracks/bays. Combination of colors and colour coding to denote various transit lines or routes or tracks within a system will help passengers not only in easily identifying busses departing various routes but also makes information more memorable.

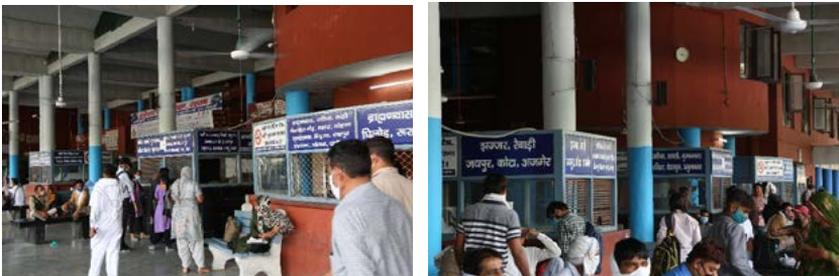
Fig. 5 Ticket windows for various destinations or routes. Photo source: Author

All ticket windows are located near to the tracks/bay but not parallel to it. These counters are not numbered or designated with numbers as mentioned on tracks/bays which again creates chaos on platform when passengers cannot easily identify ticket counter from which they need to purchase tickets. Proper numbering and colour coding can help in quick interpretation of information. There are no specific information available related to the fare or ticket charges; passengers ask and pay on counter itself.

There are no advance and conformational directional signage within station area. Directional signs at every decision point should be placed for uninterrupted movement and availability of information in advance regarding the next step or action i.e. whether to turn right, left, or go straight ahead. This will help passengers in identifying their location within terminal and aid in wayfinding decision-making.

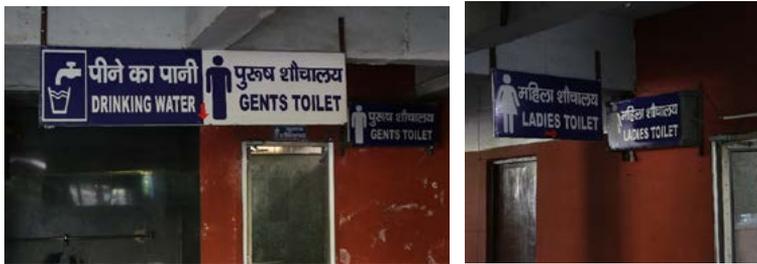
Fig. 6 Drinking water and Toilet signage Photo source: Author

The facilities of toilets are available in a corner of platform that is not visible from any side of platform or station area. Passengers often ask for directions to locate toilet. There are no advance directional sign within station area showing way toward toilets. Confirmatory directional sign is there for some toilet but it is placed very near to identification sign

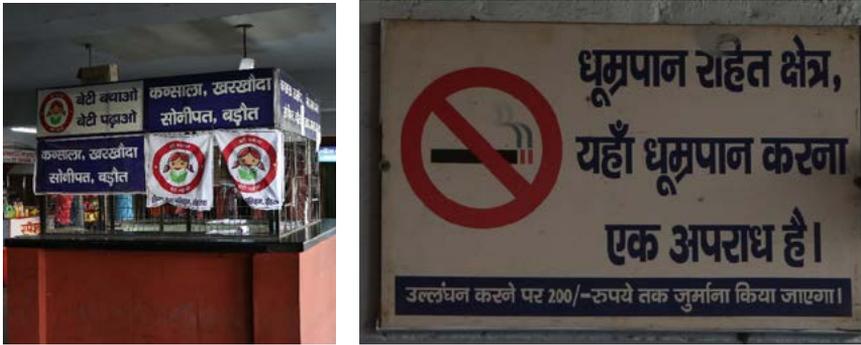
Fig. 7 Information in single language. Photo source: Author

Information is available in singular language so it cannot benefit people speaking or belonging to other language background. Information in bilingual format and accompanied by visuals/pictograms will ensure proper dispersal of information among passengers. Pictorial communication is key to help illiterate people to read. Hence it was realized that there is a need for incorporating graphics/visuals along with verbal information which will initiate universal communication thereby assisting and understood by all passengers irrespective of their cultural, literacy, and language backgrounds.

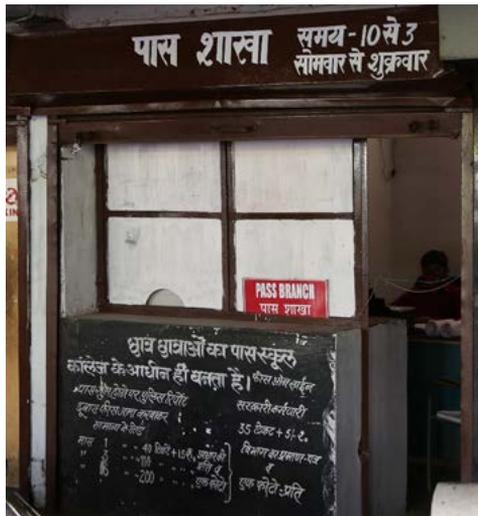
Fig. 8 Concession or bus pass counter. Photo source: Author

There are four eminent Universities in Rohtak, Maharishi Dayanand University largest university of Haryana and Pandit Laxhmichand State University of Performing and Visual Arts; Asia's only design university. Most of the passengers in utilizing bus services in Rohtak are students who commute daily from various places from Haryana or Delhi NCR to attend college or University. 25.8% respondents said in survey that they use public transport for attending college or university. The present signage system is not benefiting students and they often did not find it convenient to use services and identify routes at Rohtak bus stand. The information regarding concession or bus passes is also not presented properly. (Fig.) This is the most essential piece of information that is required by students who travel regularly.

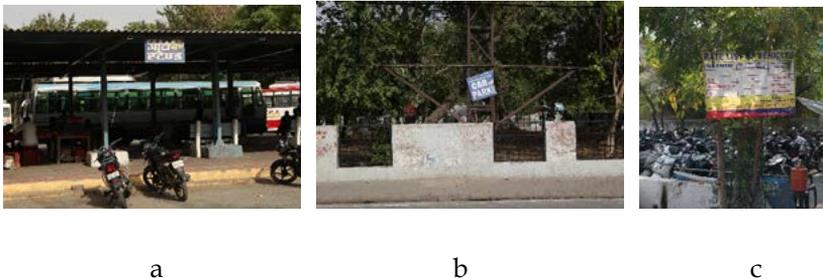
Fig. 9 Parking and auto stand signage. Photo source: Author

Sign for Car Parking has been located at wrong place and often causes confusion among visitors. (b) Parking sign is regulatory/mandatory information, which presented in circle, blue colour and pictogram / information in white. There are no directional sign or wayfinding showing way towards the parking area, which often creates confusing among visitors, and they enter gate no 2 that is the entrance for platform. Identification sign for auto stand and car/two wheeler parking are there but are not large enough or easily noticeable.

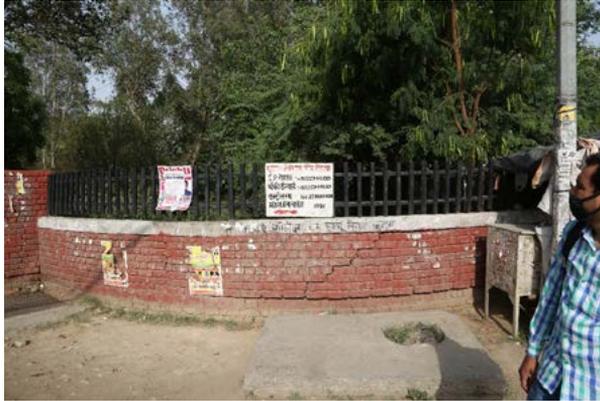
Fig. 10 Helpline no or emergency service Photo Source: Author

No emergency exit, safety & hazardous sign or other emergency signage has been displayed within station area. Safety & hazardous areas and sign should be clearly marked and emphasized by uniting various colour and texture combinations also using physical guards to prevent mishappening. Only one signboard about security or emergency information displayed outside station near gate no 3, which is also not noticeable or large enough and clear. No COVID 19 signage reminding passengers to maintain social distance and informing about safety measures or COVID 19 behaviors were displayed within station area.
